I. Executive Summary

Purpose of Submission Document and Executive Summary

The NTSB has requested that all parties to the USAir Flight 427 investigation submit proposed findings to be drawn from the evidence produced during the course of the investigation, identify a probable cause, and propose safety recommendations designed to prevent future accidents. This submission is Boeing's response to the NTSB's request.

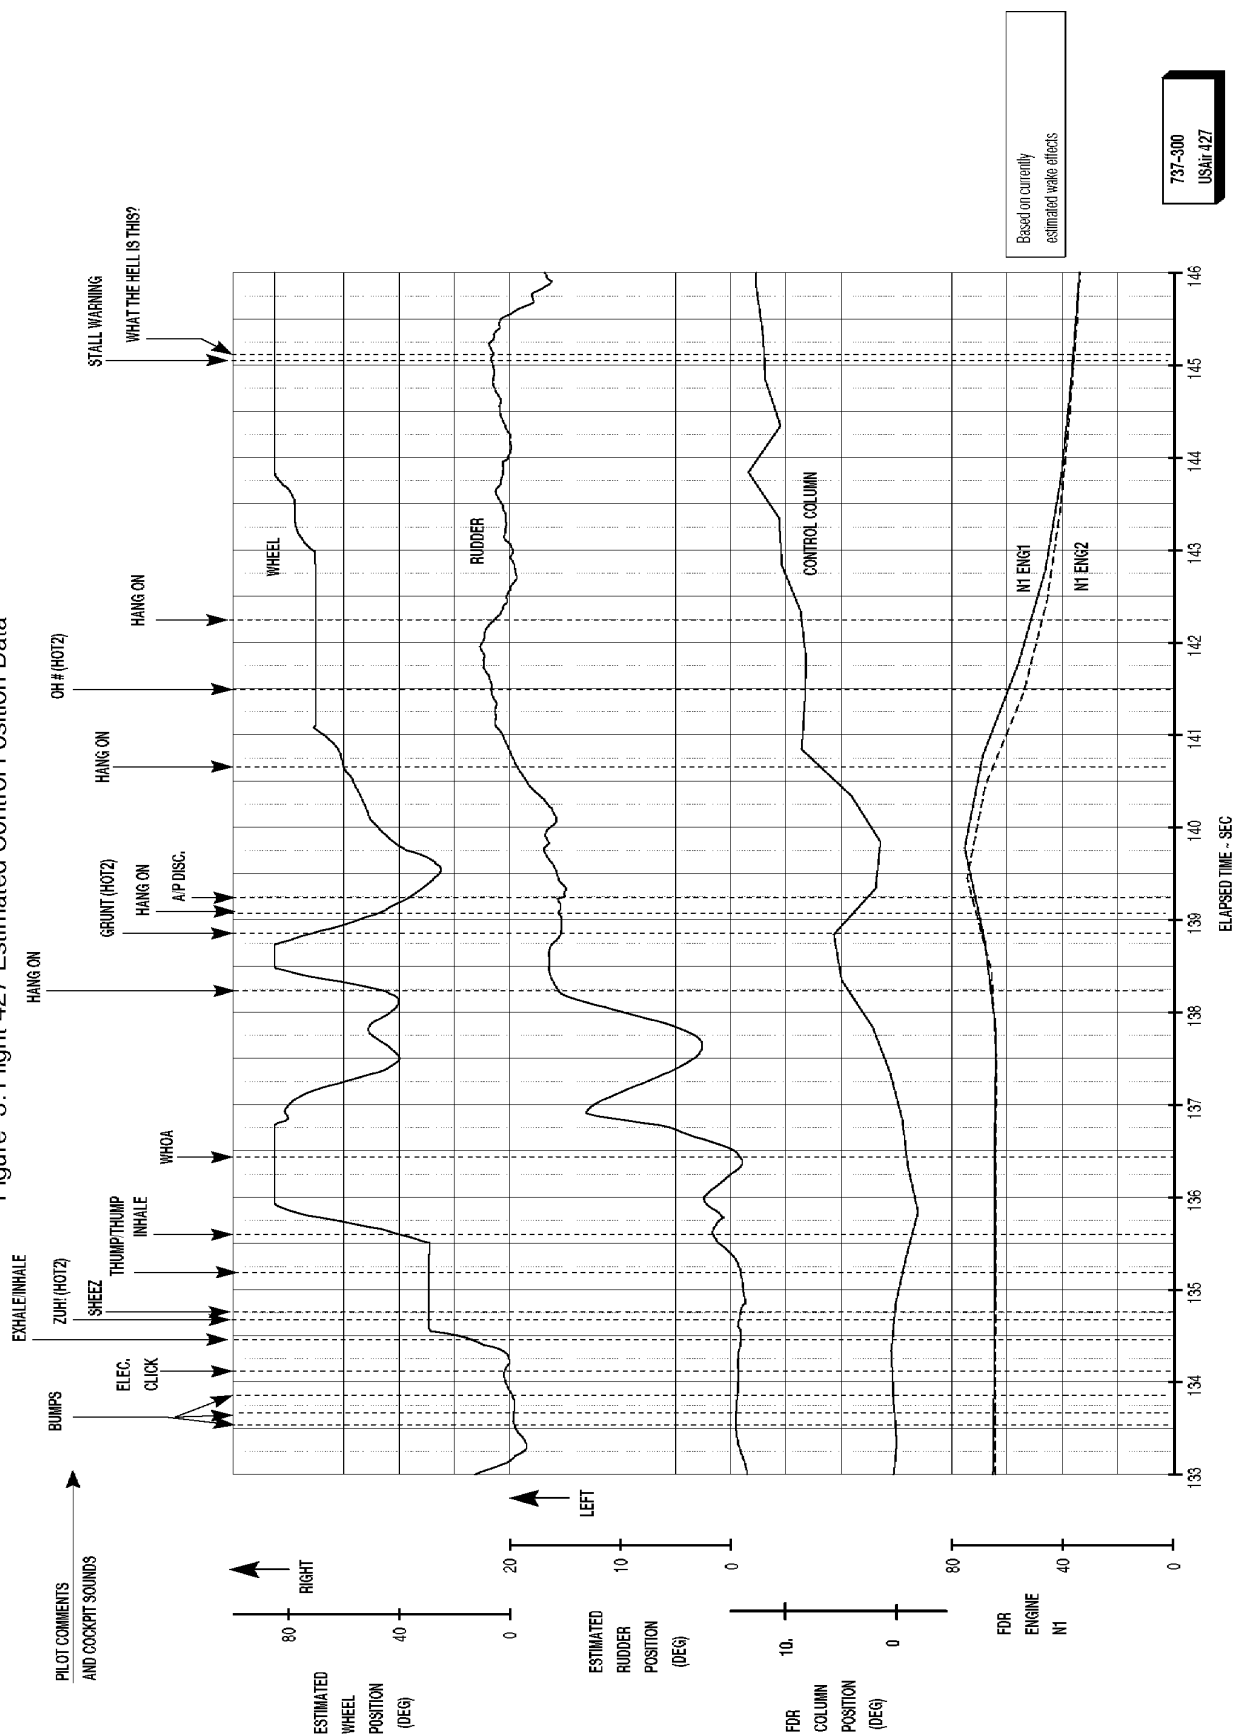
Figure 3: Flight 427 Estimated Control Position Data

The following summarizes the pertinent information obtained from the kinematic analysis:

1. Application of the wheel during the accident sequence caused the roll acceleration to oscillate to values larger than those experienced during the initial upset due to the 727 wake encounter.

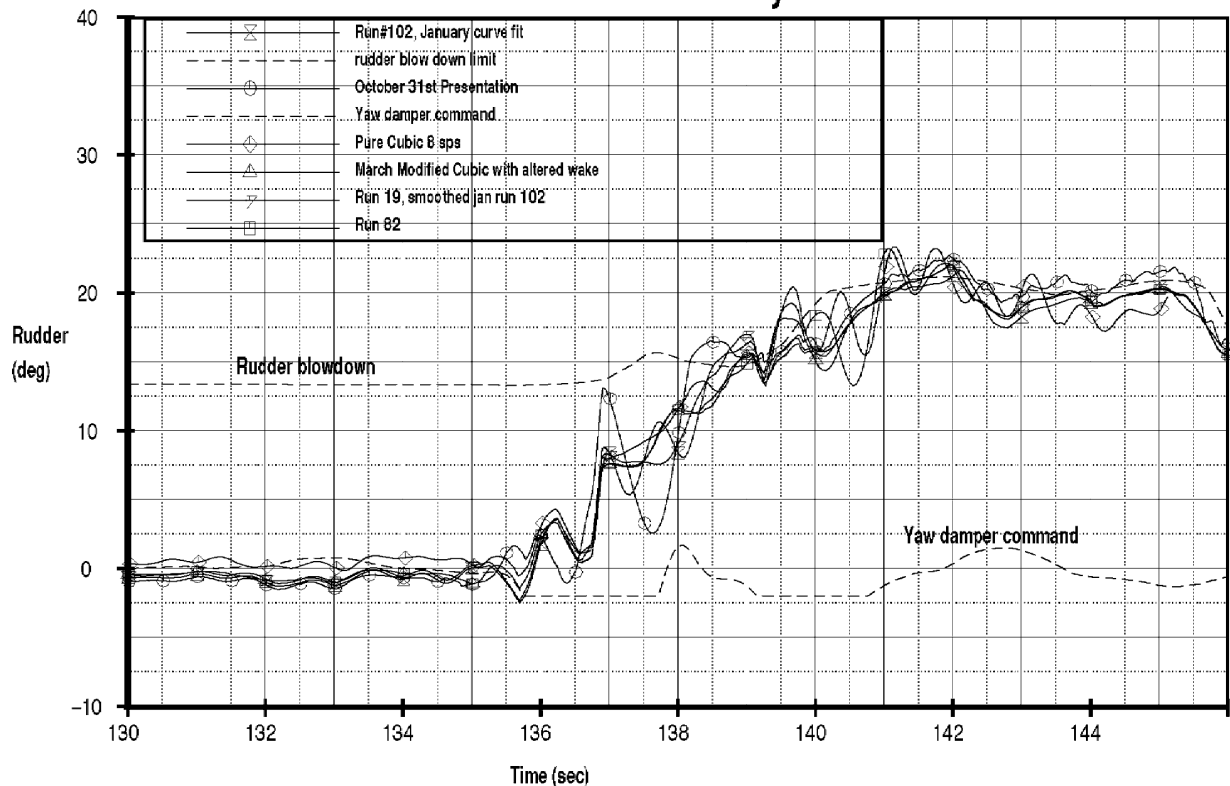
Figure 4: Results of Different Methods of Interpolating Heading Data

The NTSB Performance Group looked at several other methods of interpolating the heading data. All of the results are shown in Figure 4, and are discussed in the NTSB study. Examination of the various resulting rudder traces shows that the derived rudder before time 136.8, and after time 138.8, are essentially the same. The only difference is the rudder position time history as it transitioned from near neutral to its blowdown limit. The rudder time histories that evolved from the various analyses will be used in later analysis to evaluate pilot response and rudder system failure scenarios.

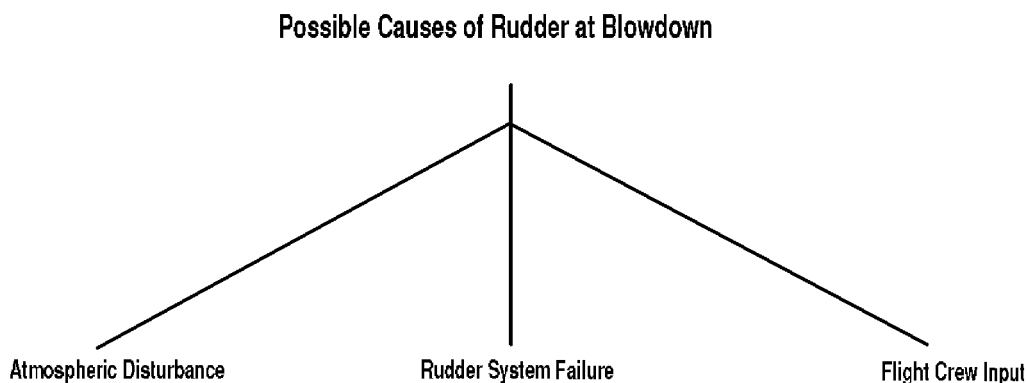
Figure 5: “Road Map” for Understanding Possible Scenarios

One of the main issues of the investigation is what caused the rudder to go to its blowdown limit, since this played a key role in the chain of events leading to the accident. During the course of the investigation, various hypothetical scenarios were put forth as the cause. These fall into three main categories: the rudder went to blowdown due to an atmospheric disturbance, a rudder system failure, or a flight crew input. Figure 4 shows the various rudder time histories determined by the kinematic analysis described in Section II. Figure 5 shows the different scenarios that have been proposed. This section discusses these possibilities and then lays out the plan for reviewing the evidence as to whether these hypothetical scenarios could have occurred on the accident flight.

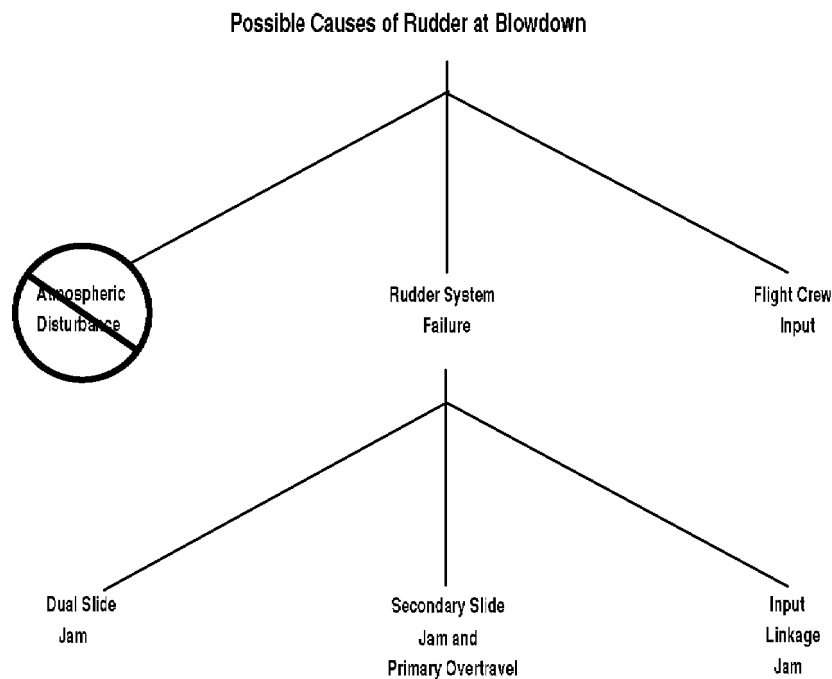
Figure 6: Revised "Road Map" for Understanding Possible Scenarios

As a result of the above discussion, Figure 5 can be updated as shown in Figure 6. The atmospheric disturbance branch has been dropped, and the various rudder failure modes have been added.

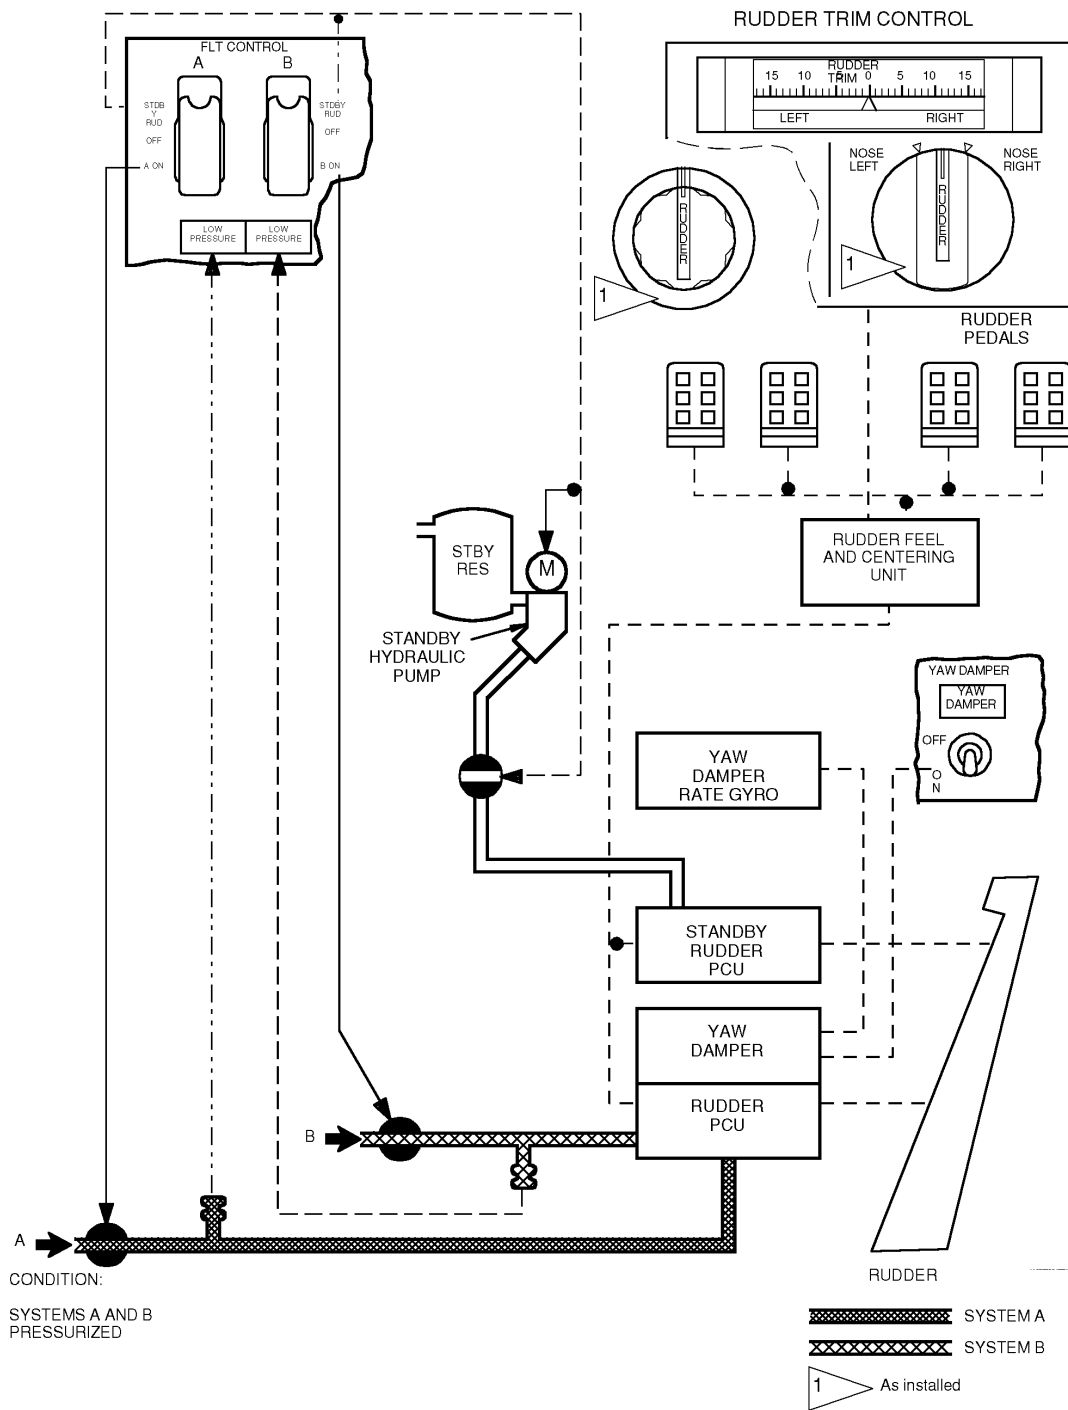
Figure 7: Rudder Control System Schematic

Figure 7 also shows the yaw damper system, which is designed to improve airplane ride quality by minimizing small-amplitude yaw oscillations. The yaw damper electronic module, or coupler, provides an electrical signal to the

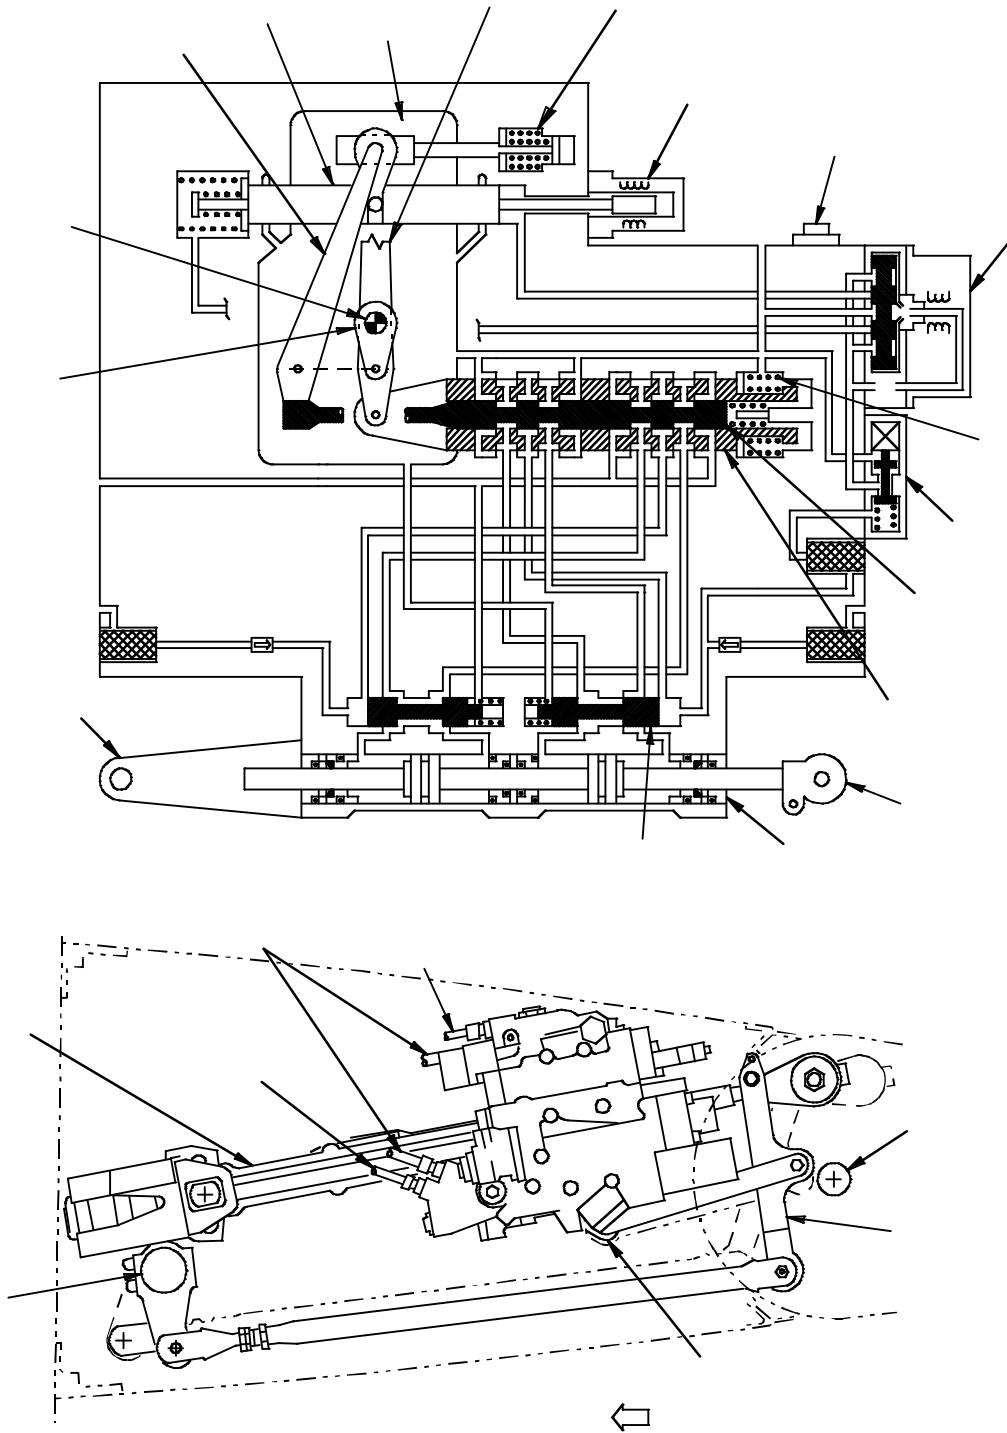
Figure 9: Main PCU Functional Schematic

Figure 9 provides a schematic view of the main PCU. The main control valve is connected through a dual-load-path linkage to both the yaw damper piston and to the pilot input linkage. The linkage sums inputs by the pilots and yaw damper to the control valve. The yaw damper piston is controlled by an electro-hydraulic servo valve that receives an electrical input from the yaw damper couple. The yaw damper piston in the Flight 427 PCU (as in all 737-300 airplanes) is limited by a mechanical stop that only allows it to command three degrees of rudder.

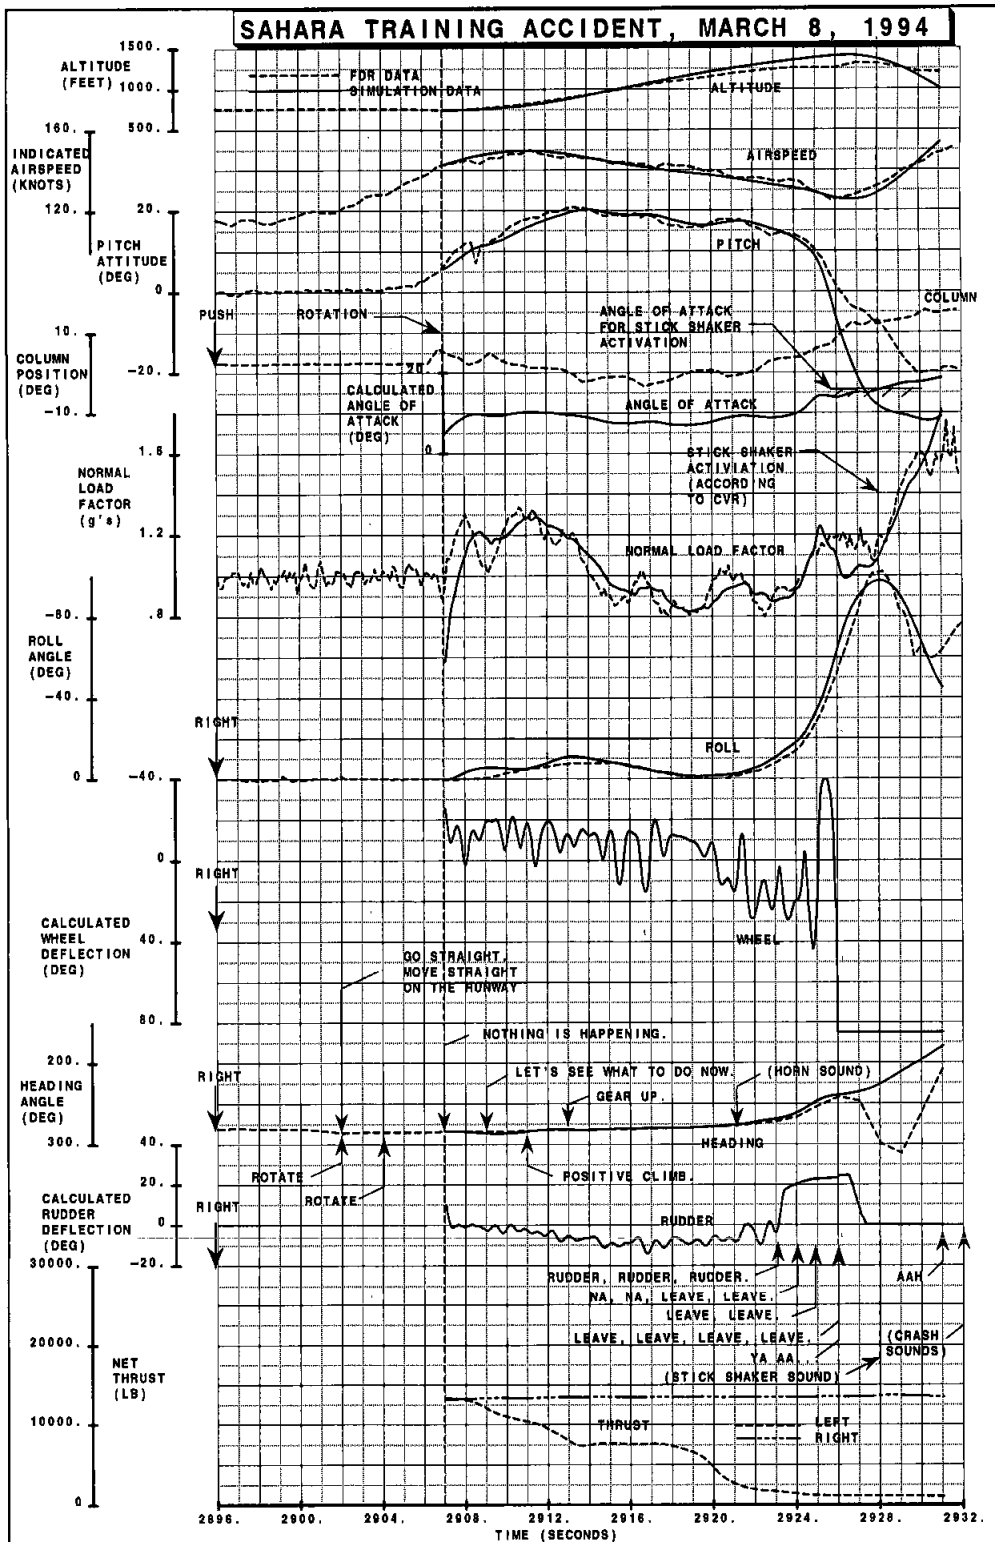
Figure 11: Sahara India Airlines Training Accident

The following summarizes pertinent information obtained from the simulator analysis:

1. The rudder was operational during the simulated engine failure.
2. The rudder was operational during the final seconds of the Sahara accident.
3. Wheel alone was not sufficient to reverse the rapid roll to the left; only the removal of the left rudder could have resulted in the bank angle time history recorded on the DFDR.
